**PUBLIC WORKS
CENTER
GUAM
FLEET MOORINGS
UNDERWATER
INSPECTION
REPORT**

SEPTEMBER 1983

OCEAN ENGINEERING
AND CONSTRUCTION PROJECT OFFICE
CHESAPEAKE DIVISION
NAVAL FACILITIES ENGINEERING COMMAND
WASHINGTON, D.C. 20374

FPO-1-83 (32)

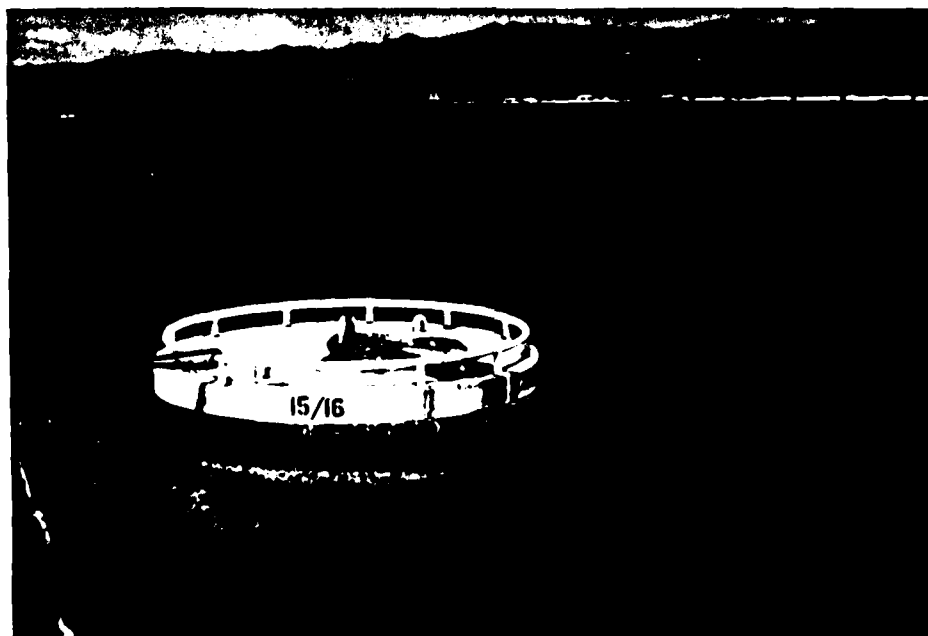
Typical Good Condition of Recently Overhauled Buoys
